PIC12F508/509 Rev. B0 Silicon/Data Sheet Errata

The PIC12F508/509 parts you have received conform functionally to the Device Data Sheet (DS41236E), except for the anomalies described below.

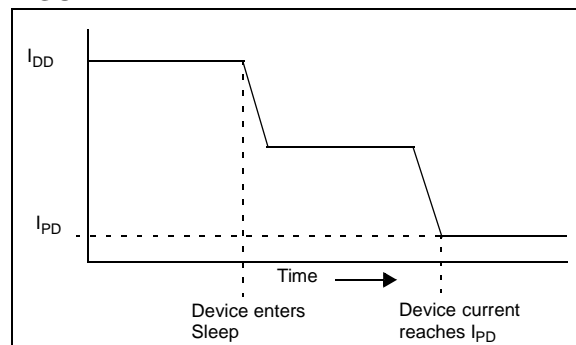
FIGURE 1:

On the PIC12F508/509 silicon, revisions earlier than A3, the power-down base current may remain higher than the specification for a short time when entering Sleep.

The following graph illustrates the device current upon entering Sleep:

The length of time between the device entering Sleep mode and the device current reaching I_{PD} increases as both temperature and voltage decrease.

This issue is fixed in Revisions A3 and later.
