Device TC1762
Marking/Step EES-AC, ES-AC, AC
Package PG-LQFP-176-2

02971AERRA

This Errata Sheet describes the deviations from the current user documentation.

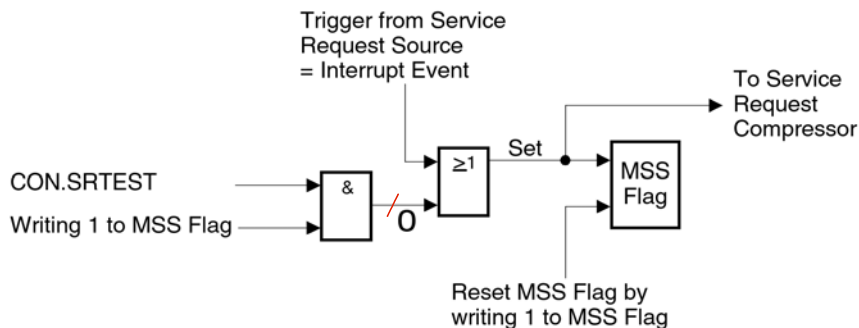
Figure 1

ADC_TC.023 Setting the MSS-flag doesn't generate an interrupt in TEST-MODE

It is possible to generate a software triggered interrupt event in TESTMODE (`ADCx_CON.SRTEST=1`) by setting one of the bitflags in register `ADCx_MSS0/1`. Due to the fact, that this mechanism is not working, it is not possible to generate a corresponding interrupt by software.

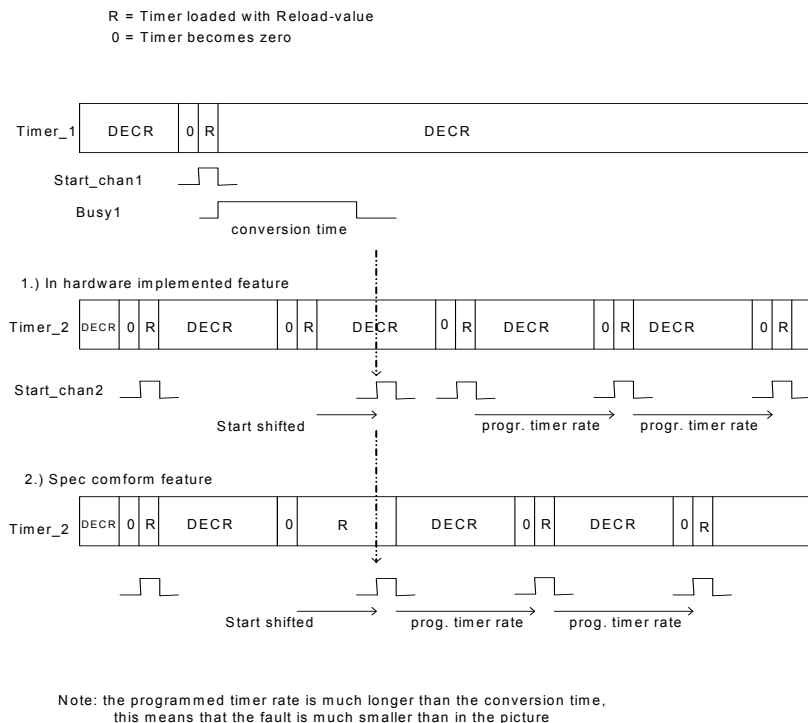
The correct behavior would be a reload when the requested conversion (of channel_2) is started.

Therefore the start of conversion for channel_2 is delayed by maximum one conversion-time. After this delay it will be continued with equidistant conversion-starts. Please refer to the following figure.

Figure 2 Timing concerning equidistant multiple timers

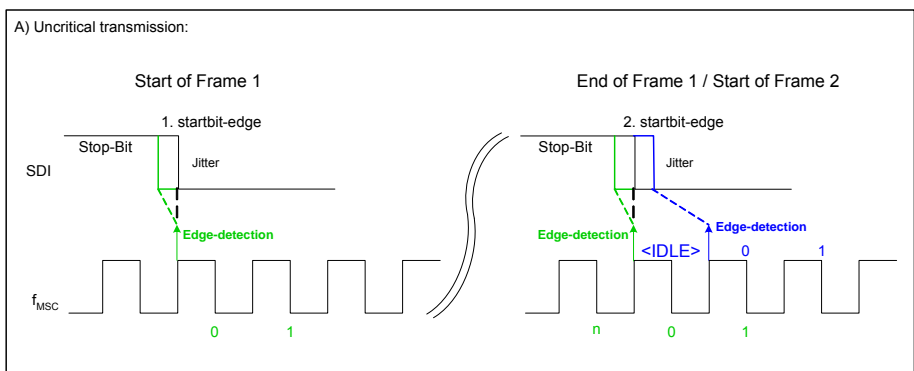
Figure 3 Uncritical transmission

As the falling startbit edge is shifted to the left of the rising clock edge (**Figure 3** left), there occurs a secure detection of the next startbit edge in the last cycle of the previous frame (here cycle n, **Figure 3** right) independent from the applied jitter to this edge.

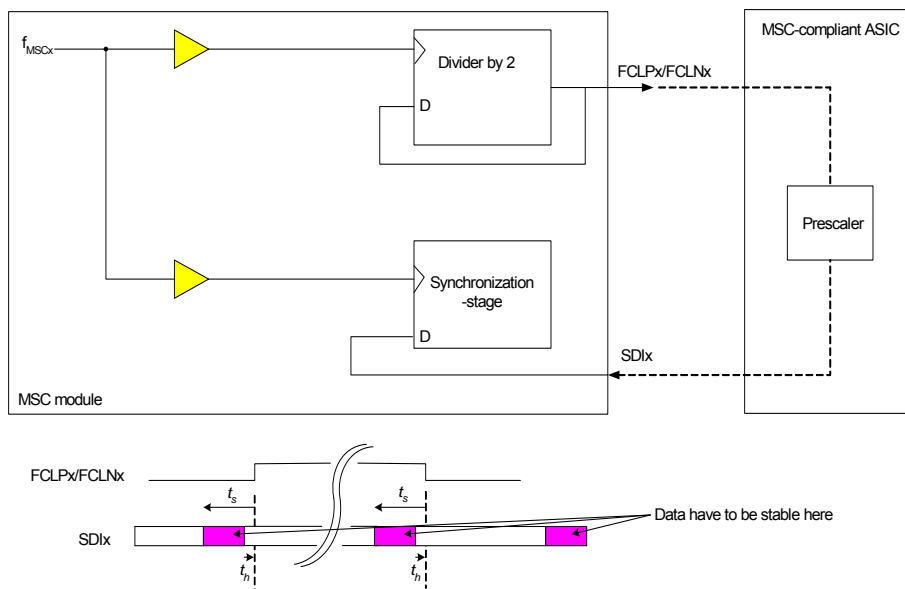
Figure 5 shows the principle blockdiagram of the input synchronization stage of the MSC module.

Figure 5 Delay adjustment relative to the module clock

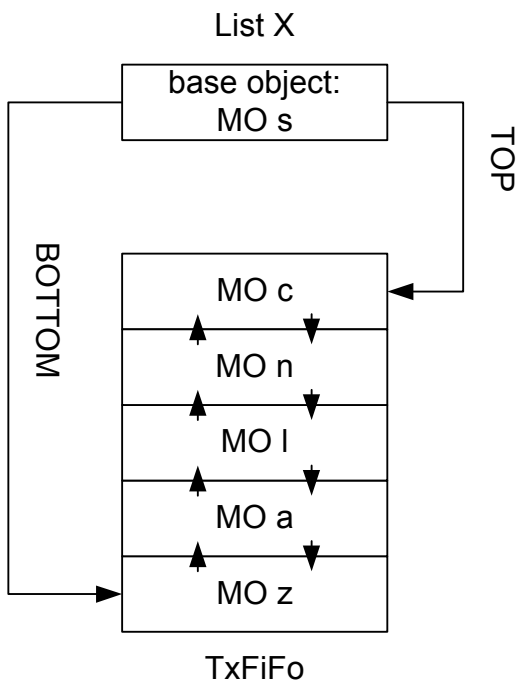
Figure 6 FIFO structure

If Tx FIFO overflow interrupt needed, take the FIFO base object out of the circular list of the Tx message objects. That is to say, just use the FIFO base object for FIFO control, but not to store a Tx message.

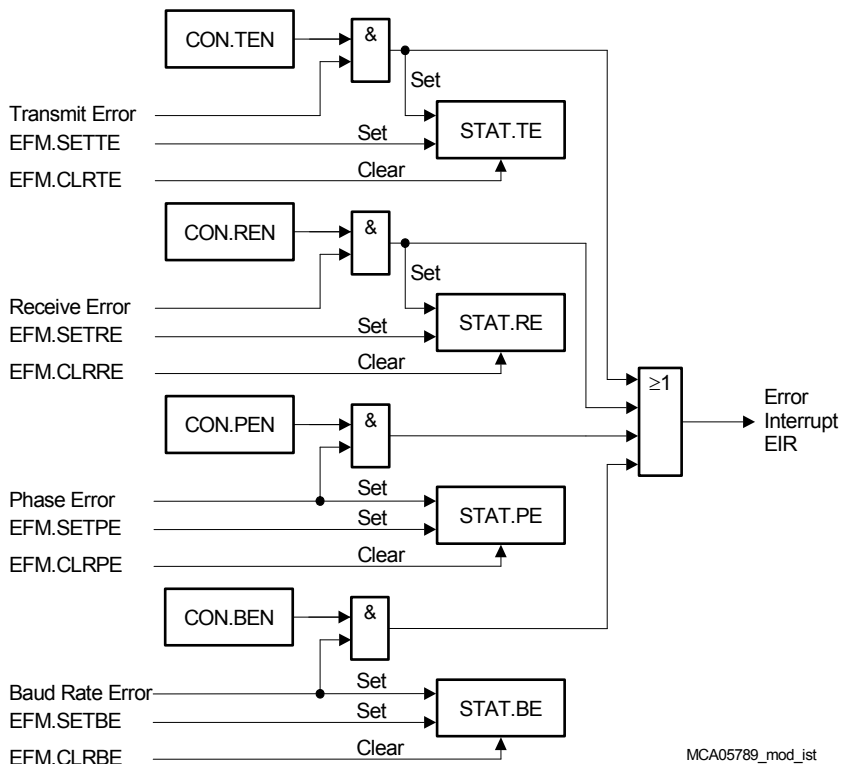
The SSC is able to detect four different error conditions. Receive Error and Phase Error are detected in all modes, while Transmit Error and Baud Rate Error apply to Slave Mode only. In case of a Transmit Error or Receive Error, the respective error flags are set and the error interrupt requests will be generated by activating the EIR line only if the corresponding error enable bits have been set. In case of a Phase Error or Baud Rate Error, the respective error flags are always set and the error interrupt requests will be generated by activating the EIR line only if the corresponding error enable bit has been set. The error interrupt handler may then check the error flags to determine the cause of the error interrupt. The error flags are not reset automatically, but must be cleared via register `EFM` after servicing. This allows servicing of some error conditions via interrupt, while others may be polled by software. The error status flags can be set and reset by software via the error flag modification register `EFM`.

Figure 8 SSC Error Interrupt Control

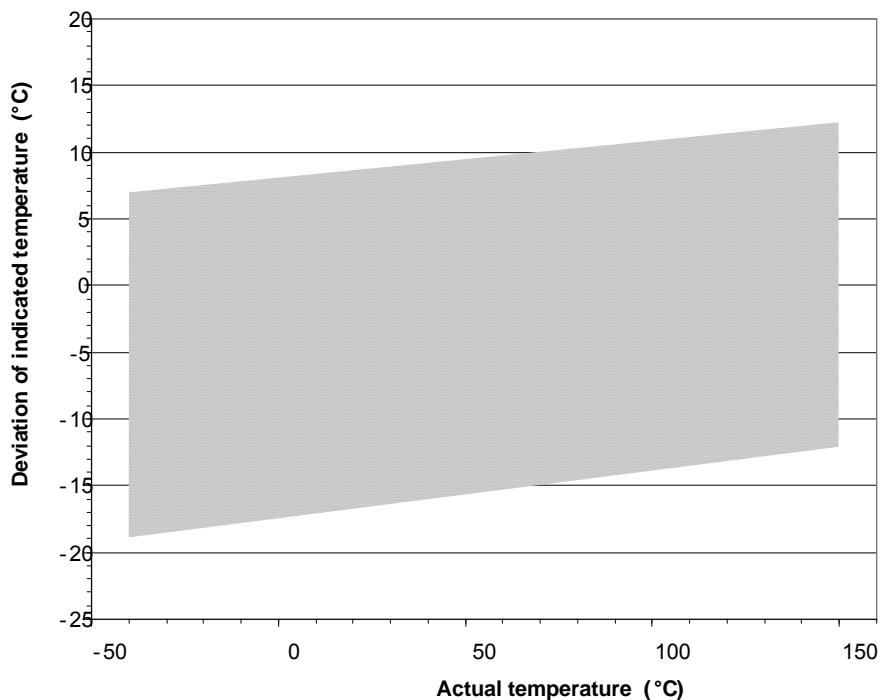
- +/-12°C at $T_j = 150^{\circ}\text{C}$
- +9/-17°C at $T_j = 25^{\circ}\text{C}$
- +7/-19°C at $T_j = -40^{\circ}\text{C}$

Figure 9 Current accuracy range
Workaround

To keep the accuracy within the specified margins of $\pm 10^{\circ}\text{C}$, the following formula to calculate the die temperature is available if MSB of the byte at D000 0003_H is 1_B:

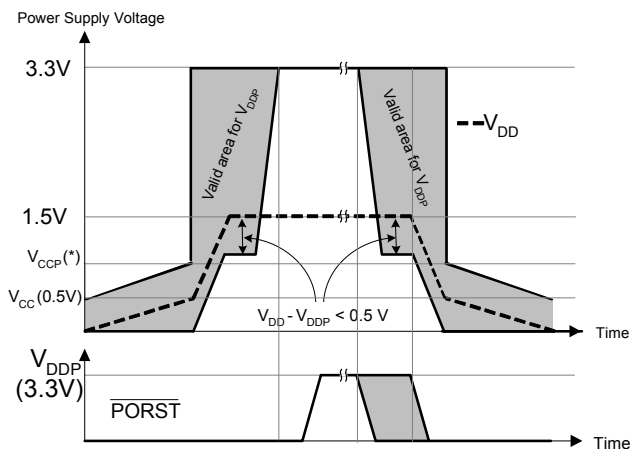
- All analog voltages (V_{DDOSC3} , V_{DDM} , V_{DDMF} , V_{DDFL3}) must also follow V_{DDP} power-up/down sequence.
- V_{DDAF} , V_{DDOSC} must follow V_{DD} power-up/down sequence.
- The absolute value of the maximum allowed deviation between any two supplies is 0.5 V while the 1.5V supplies are below their specified operating conditions.

Figure 10 Exemplary power-up/down sequence

Note: V_{CC} and V_{CCP} in **Figure 10** refer to devices with *PWR_TC.P009* erratum.

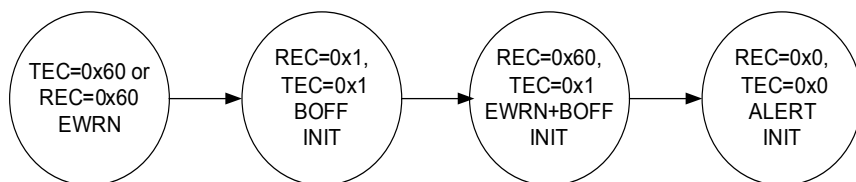
MultiCAN AI.H007 Alert Interrupt Behavior in case of Bus-Off

Figure 11 Alert Interrupt Behavior in case of Bus-Off

When the threshold for error warning (EWRN) is reached (default value of Error Warning Level EWRN = 0x60), then the EWRN interrupt is issued. The bus-off (BOFF) status is reached if TEC > 255 according to CAN specification, changing the MultiCAN module with REC and TEC to the same value 0x1, setting the INIT bit to 1_B, and issuing the BOFF interrupt. The bus-off recovery phase starts automatically. Every time an idle time is seen, REC is incremented. If REC = 0x60, a combined status EWRN+BOFF is reached. The corresponding interrupt can also be seen as a pre-warning interrupt, that the bus-off recovery phase will be finished soon. When the bus-off recovery phase has finished (128 times idle time have been seen on the bus), EWRN and BOFF are cleared, the ALERT interrupt bit is set and the INIT bit is still set.
